DRAFT ROUND 10 DAM ASSESSMENT REPORT NIPSCO BAILLY GENERATING STATION COAL ASH IMPOUNDMENTS

NOVEMBER 11, 2011

**GZA GeoEnvironmental, Inc.
19500 Victor Parkway, Suite 300
Livonia, MI 48152
GZA File No. 01.0170142.30**

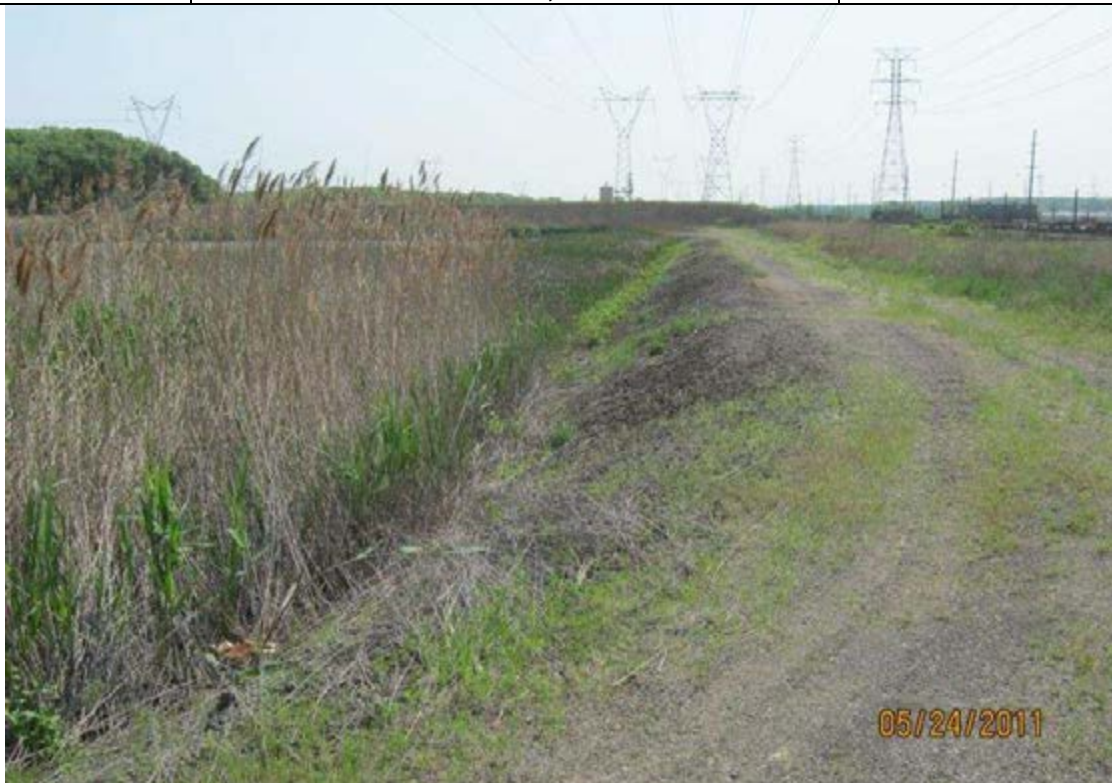
Description:
Interior slope of Primary
Settling Pond No. 1
embankment.

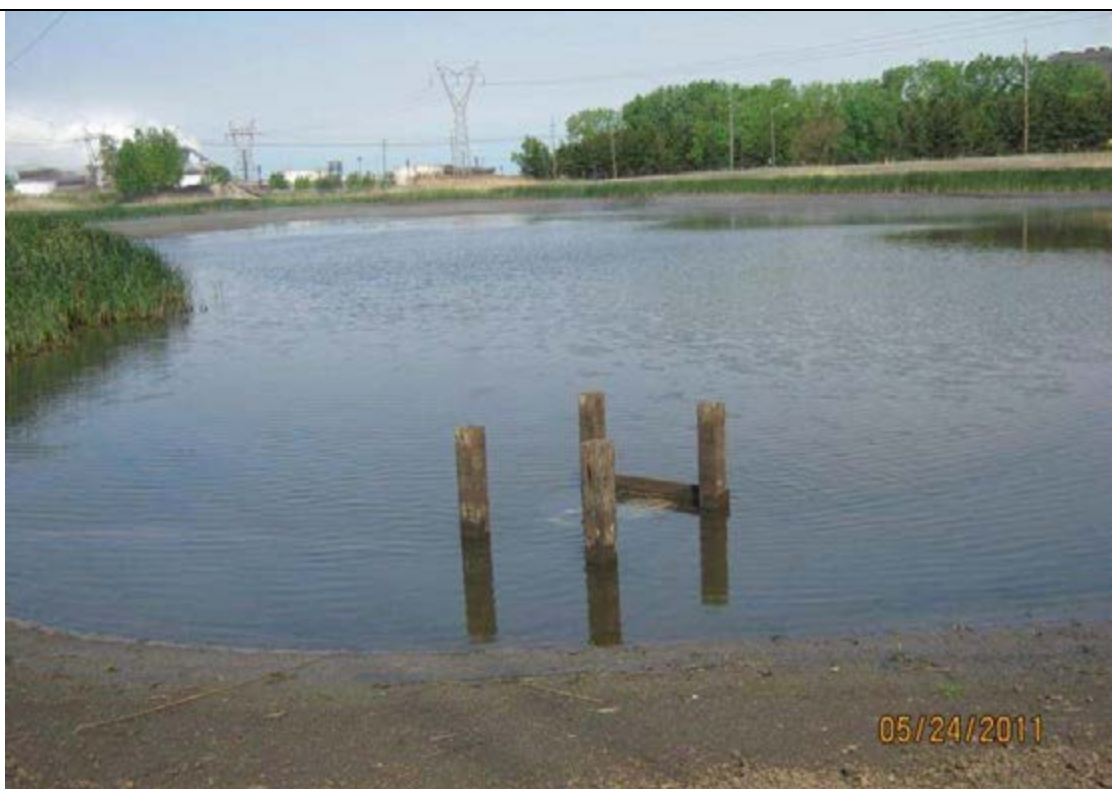
Photo No.
6

Description:
Primary Settling Pond No. 1,
including the decant
structure.

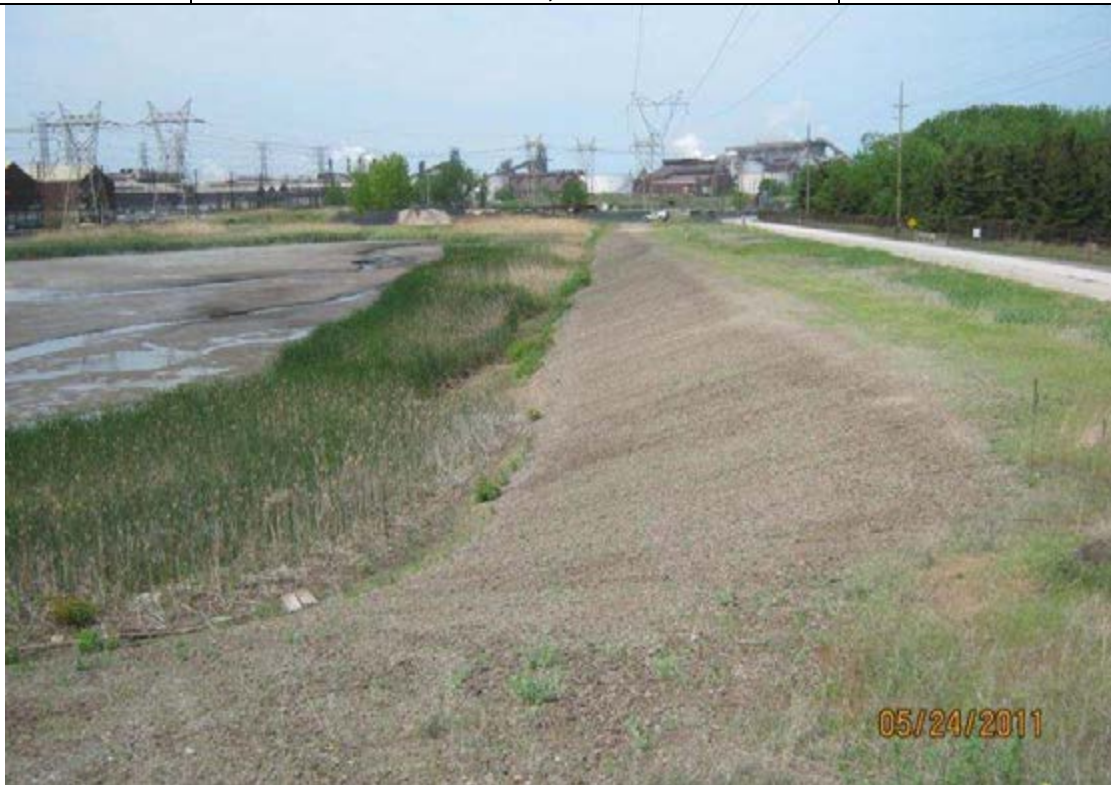
Description:
Interior of Primary Settling
Pond No. 1.

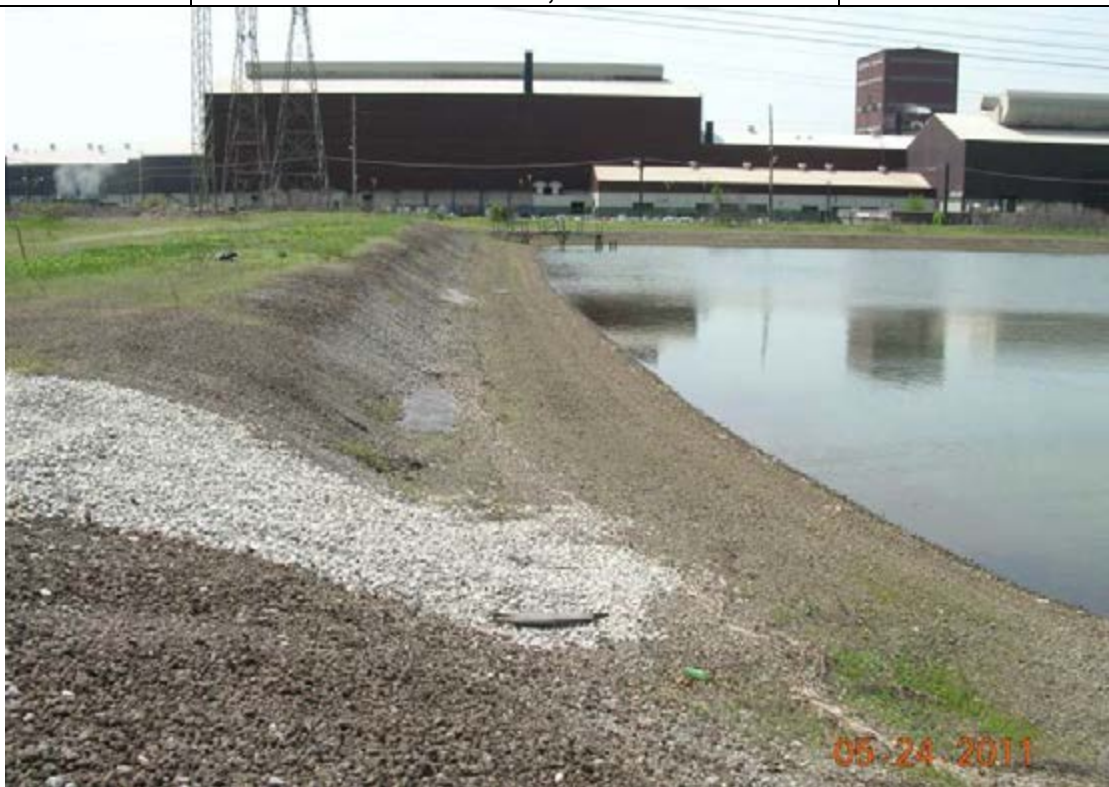
Description:
Eastern interior embankment of Primary Settling Pond No. 2.

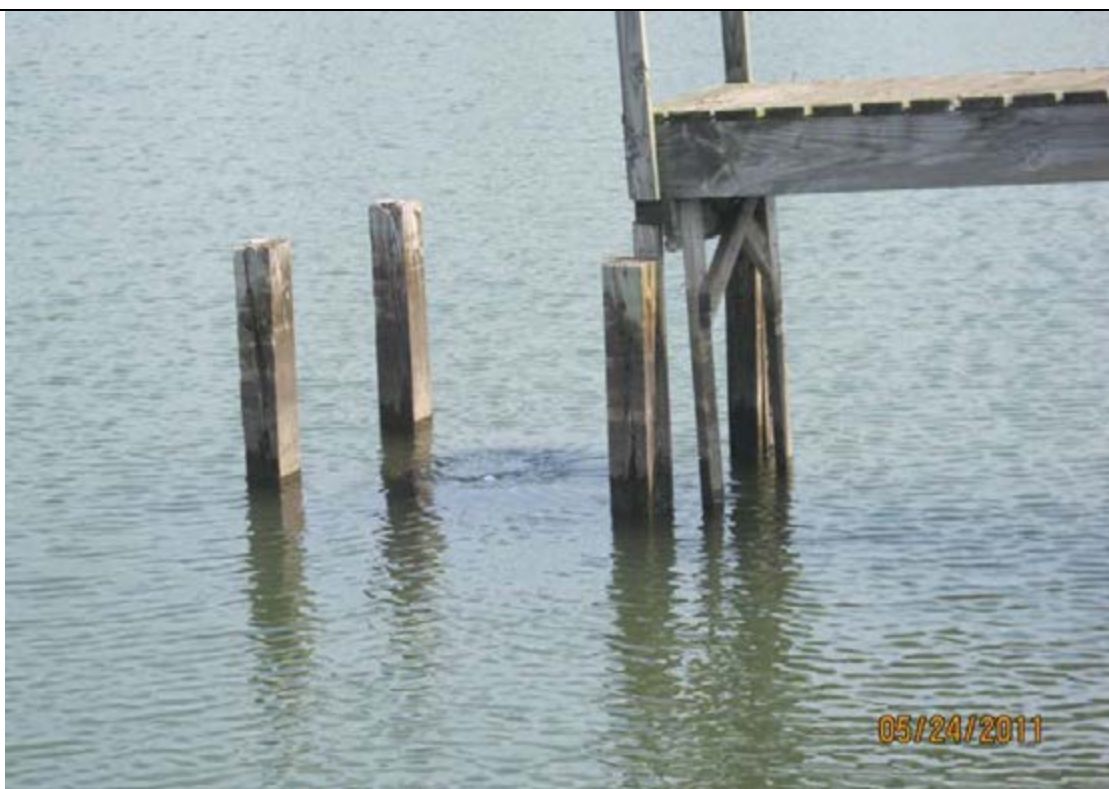
Photo No.
10

Description:
Decant structure in Primary Settling Pond No. 2.

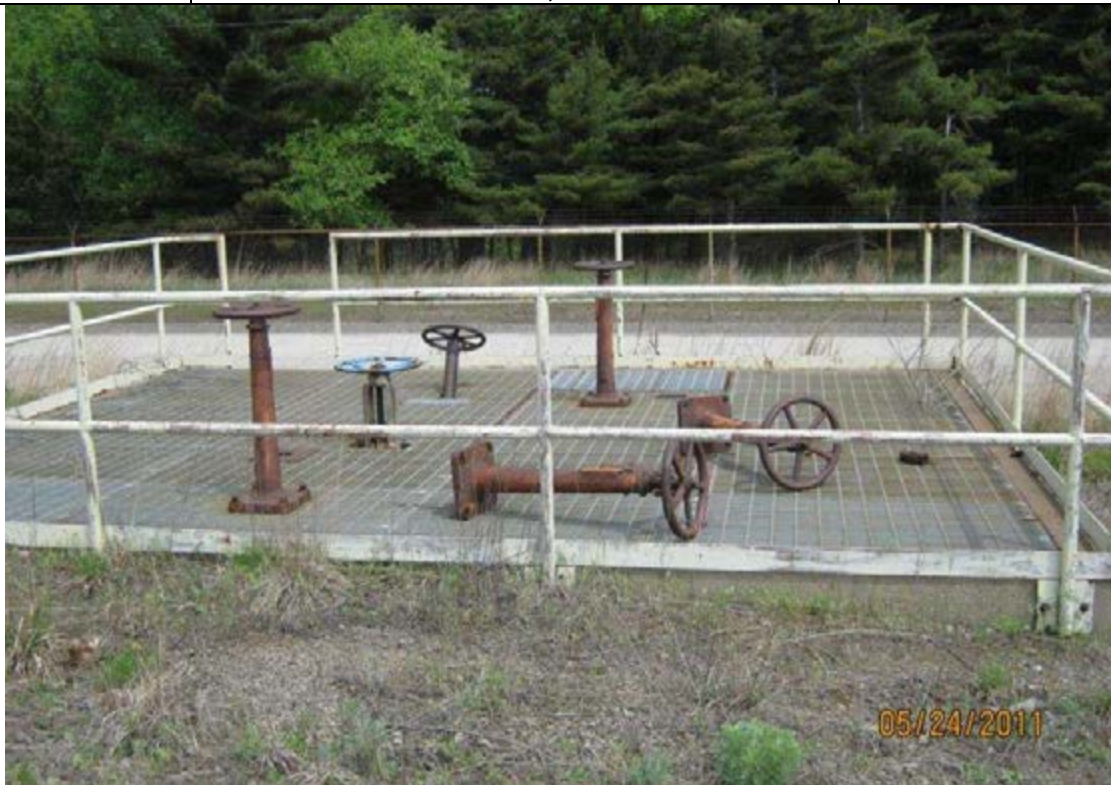
The pump house and valve pits were not assessed during GZA's site visit as these were outside of the scope of work (Photos 15, 23, 26, and 28). The transfer and discharge pipes between the Impoundments could not be visually evaluated during the assessment due to the level of water within the Impoundments. Several monitoring wells were observed at various locations near the Impoundments (Photos 14 and 29).

Valve pit to control and direct the influent wastewater flow from the BGS.
